## SPATIAL AND TEMPORAL VEGETATION TYPES AND PATTERNS IN AERIAL PHOTOGRAPHY AND ON THE GROUND TODAY – WHAT DO THEY TELL US?

## Stephen Smith Cape Cod National Seashore Gull Pond Report

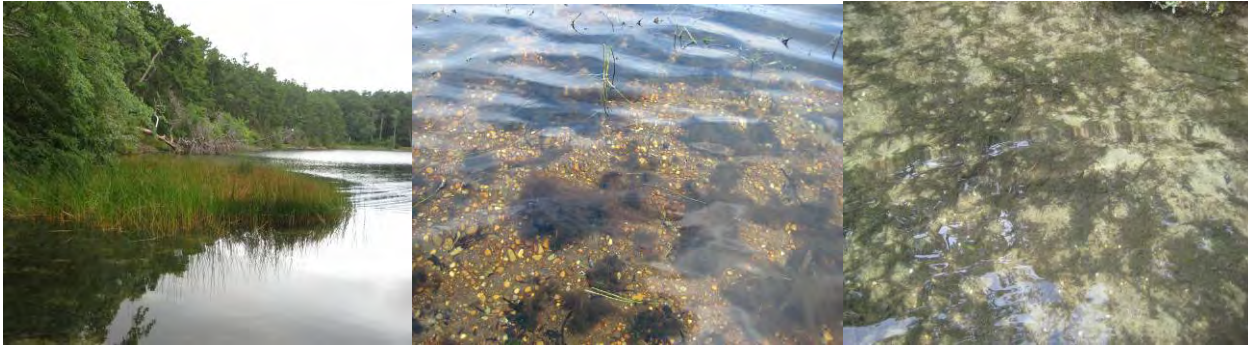
*Above: emergent macrophytes (left), submerged periphyton (middle), and organic matter (right) – all of which produce a dark signature in aerial photography that contrasts with bare sand.*

Dark signatures within the littoral zone of kettle ponds indicate the presence of one or all of the above components, although it is predominantly macrophytes, periphyton, and mosses that make up the signatures visible in aerial photographs (these components are what dominate in the ponds now). Hereafter I have referred to this signature as “ground cover”. These contrast sharply with areas of bare sand, which give a bright white signature and are obvious around areas of high disturbance (e.g., public “beaches”).

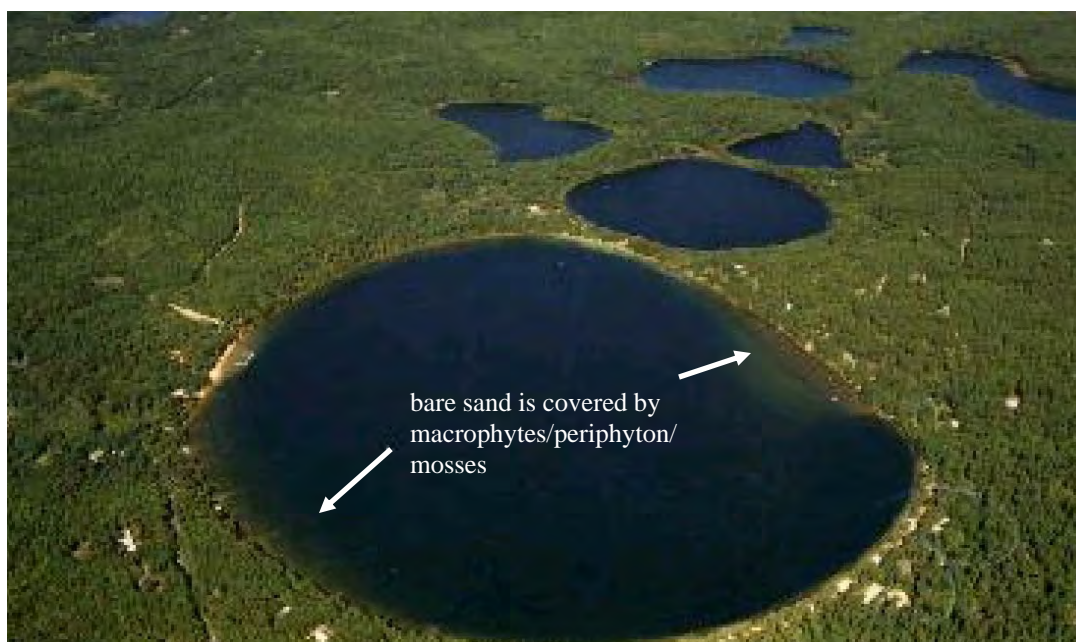
*Above – Aerial photo showing coverage of macrophyte/periphyton communities along the NE and SW shoreline of Gull Pond in the early 1990s (exact date of photo unknown but photo was taken prior to 1995). Bare sand areas are mostly limited to the sluiceway, the town beach, and the pathways of individual homeowners.*

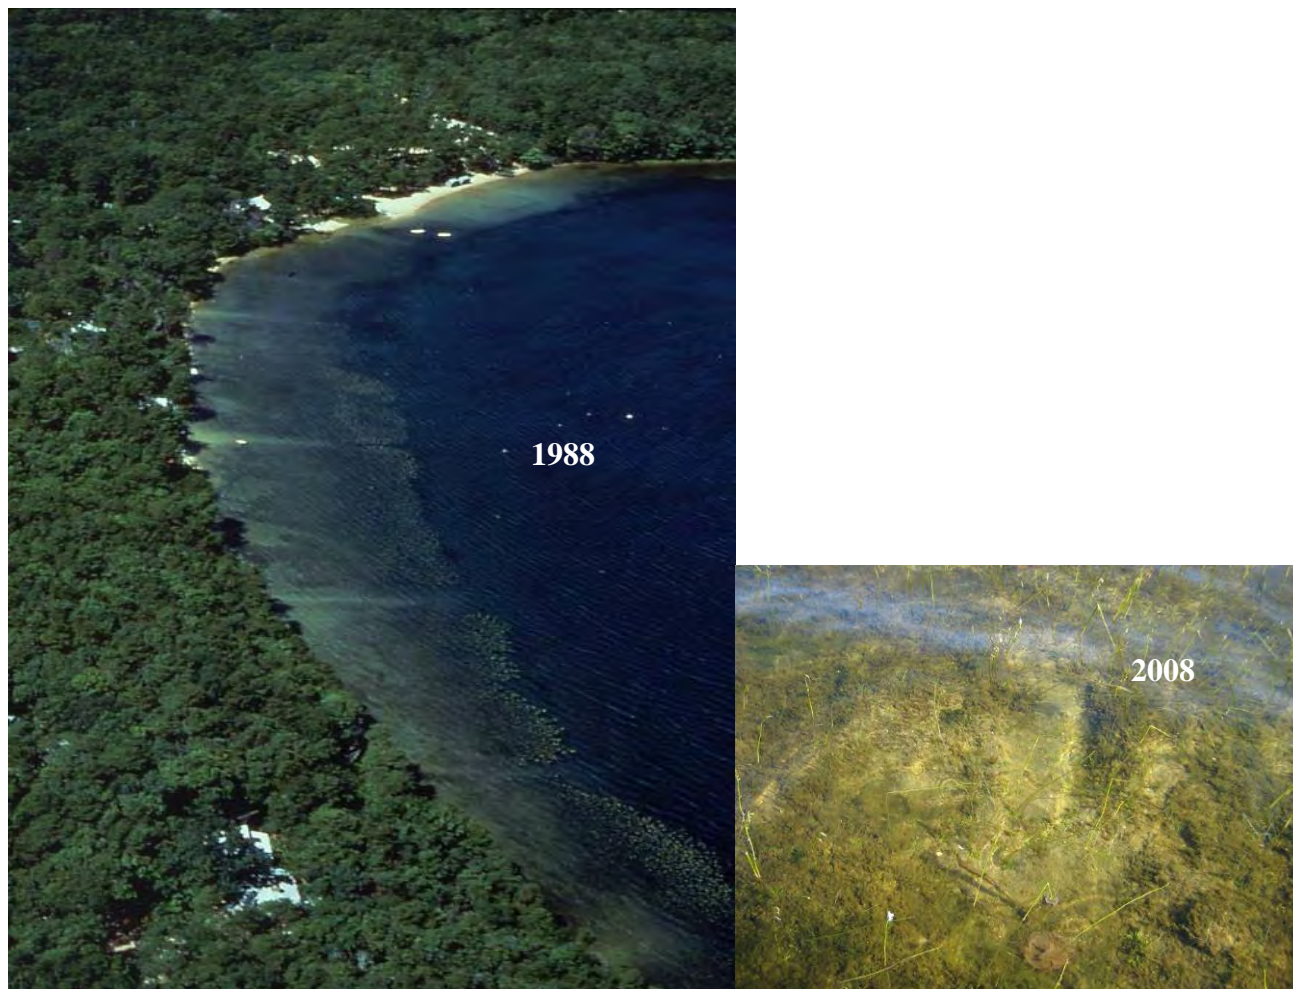
Above: Aerial photo taken 20 years ago (1988) of the SW shoreline (left). This photo shows an extensive littoral zone macrophyte/periphyton community with a water lily fringe along the outer border (deepest water). The right side photo is representative of the community in this area today (Sept 3, 2008).

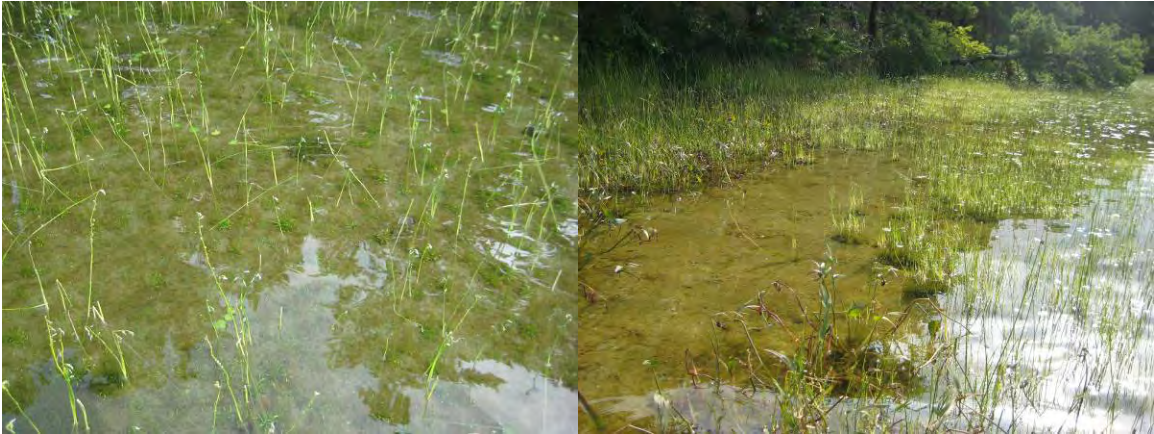
*Present-day vegetation composition and comparison to other Wellfleet Ponds* - The plant community along the NE shoreline of Gull Pond is dominated by *Lobelia dortmanna* (water lobelia) – a species considered to be an indicator of oligotrophic (pristine) conditions. In fact this plant is listed as a species of Special Concern in Rhode Island and Endangered in New Jersey. Other prominent species include *Eleocharis acicularis* and *Drapanocladus* moss. There is only scattered *Ponterdia cordata*. Periphyton clings to most of the Lobelia stems and forms a relatively solid cover over *Eleocharis* and *Drapanocladus* spp. In general, however, the macrophyte/periphyton community here does not appear any denser than in the rest of Gull Pond. The vegetation does extend farther out from shore, but this is only because the water remains shallow for a long ways toward the middle of the pond in this area. The emergent vegetation closely follows pond bathymetry - i.e., it stops abruptly when the water gets too deep.

*Above: Sparse macrophyte cover and openings in macrophyte cover along the NE shoreline of Gull Pond (Sep 3, 2008)*

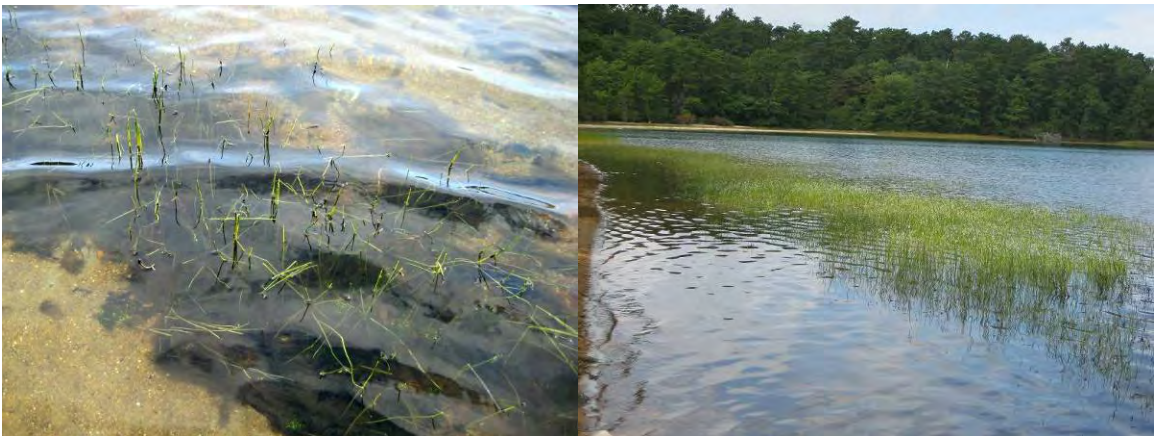
Furthermore, the same kind of macrophyte/periphyton communities can be found in many other kettle ponds. In fact, ponds that are considered much more pristine (oligotrophic) than Gull Pond have just as much, if not more, littoral zone macrophytes and periphyton - except where human-related disturbance has occurred. In September of 2008, it was my observation that Great Pond (Wellfleet) had much higher amounts of periphyton attached to *Lobelia* and other aquatic plants than in Gull Pond.

*Above: Periphyton algae on Lobelia (left) and extensive Lobelia stands (right) in Great Pond (Wellfleet) – a pond considered to be more oligotrophic and less impacted than Gull Pond. This shows that the growth of thick stands of Lobelia is likely a natural characteristic of these ponds.*

Finally, it is worth re-visiting a point made earlier. That is, other ponds in Wellfleet that are much less developed and have more oligotrophic conditions (e.g., Great Pond in Wellfleet) have extensive stands of *Lobelia* and other emergent macrophyte species (*Juncus militaris*) as well as periphyton. This strongly suggests that the development of these communities is a natural process and is not indicative of eutrophication or other

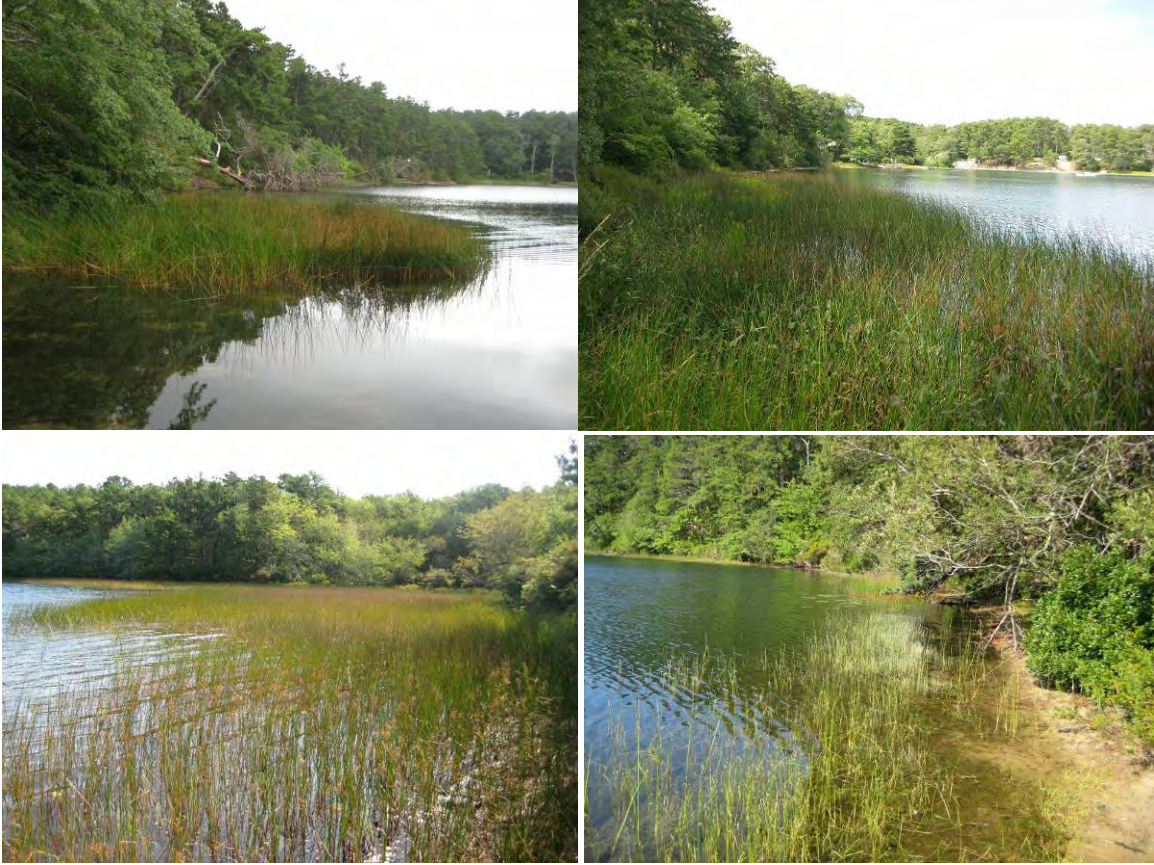
*Above: Vigorous littoral zone vegetation in Dyer (top left), Long (top right), Great-Truro (bottom left), and Ryder (bottom right) ponds. The distance that the vegetation extends into the ponds is dependent upon water depth (slope). Photos taken in late August 08.*

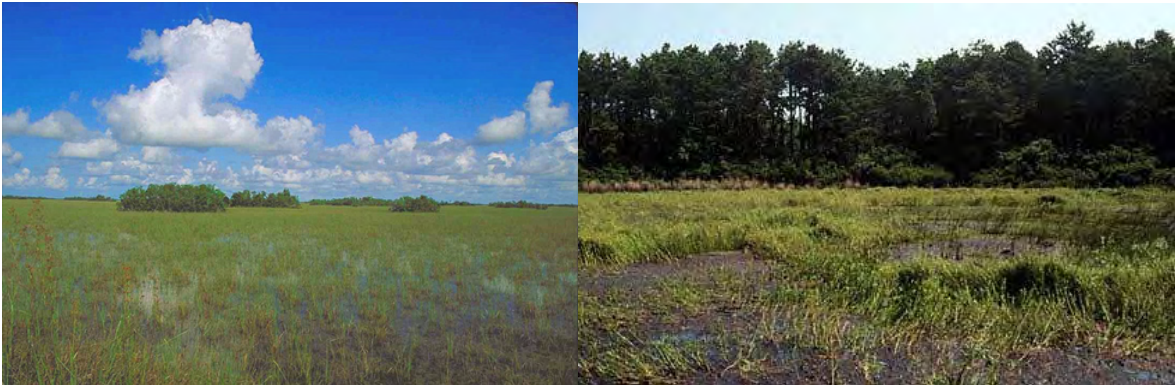
*Comparisons to other aquatic systems* – It may also be helpful to consider Gull Pond from a broader perspective. The wetlands of Everglades National Park have some of the most oligotrophic conditions anywhere. Water column phosphorus is frequently undetectable across thousands of acres of this landscape. Nonetheless, aquatic vegetation and periphyton are essentially continuous while bare, vegetation-free zones are extremely rare or non-existent. Nutrient-poor bogs and acidic fens are also some of the most nutrient-poor aquatic systems as well as being extremely acidic. However, this does not limit the growth of plant species that are adapted to such conditions (see figure below). Even in systems classified as “ultra-oligotrophic”, abundant littoral zone vegetation is a common occurrence where there are suitable substrates (i.e., not rocky bottoms), water depths, and light intensities

*Above: Photos showing dense emergent vegetation in a sawgrass wetland in Everglades National Park (left) and an acidic bog in Maine (right) – both are oligotrophic systems in very pristine settings.*

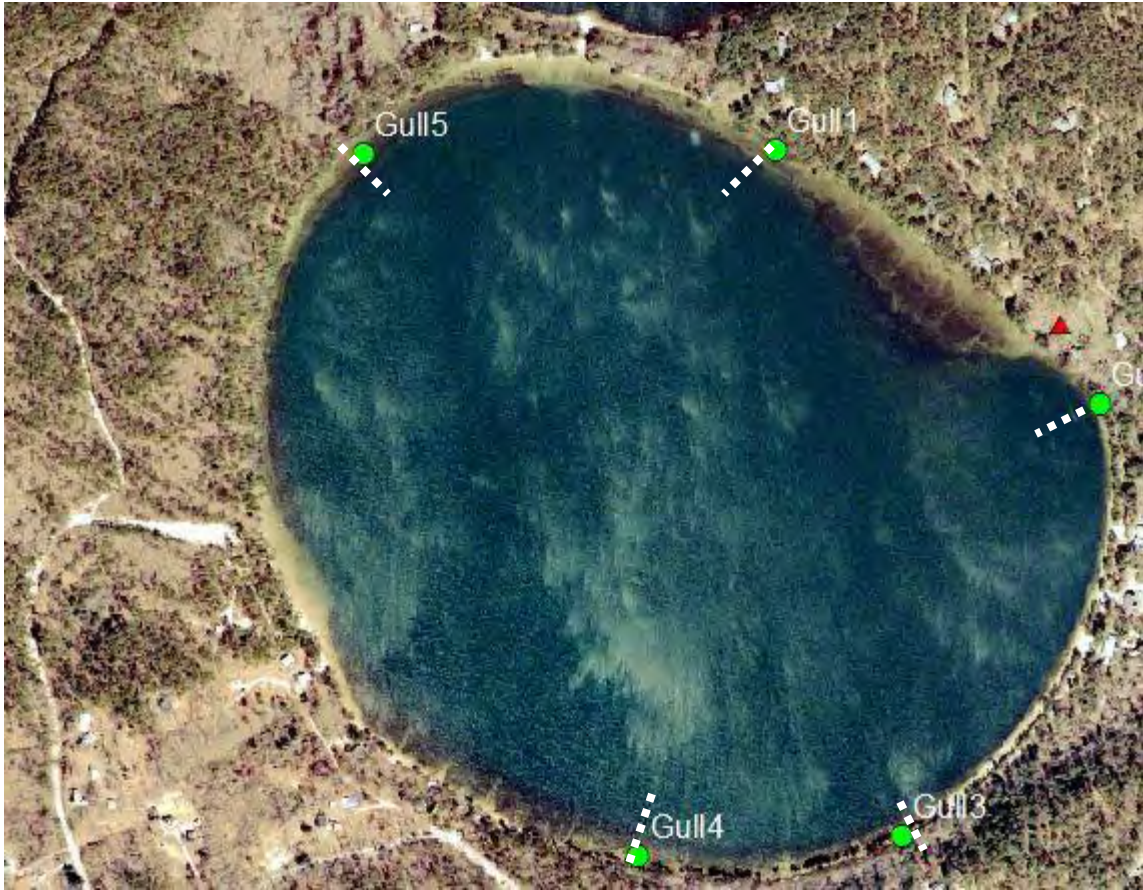
- A comparison of species composition based on data from 5 linear transects (see map below) in Gull Pond showed no significant change (Smith 2008).

*Above: Permanent vegetation monitoring transects originally established by Roman in 1995 (Roman 2001).*

- There has been a small, but non-significant change in the total cover of herbaceous (non-woody) vegetation in Gull Pond between 1995 and 2005 (Smith 2008) along the 5 monitoring transects.
- There has been no change in the distance that macrophyte vegetation extends out into the middle of the pond along the 5 monitoring transects in Gull Pond.
- There has been a significant increase in the amount of organic matter in the top 10 cm of soil between 1995 and 2005. However, all ponds except Duck showed this trend, although there were higher levels of variability.

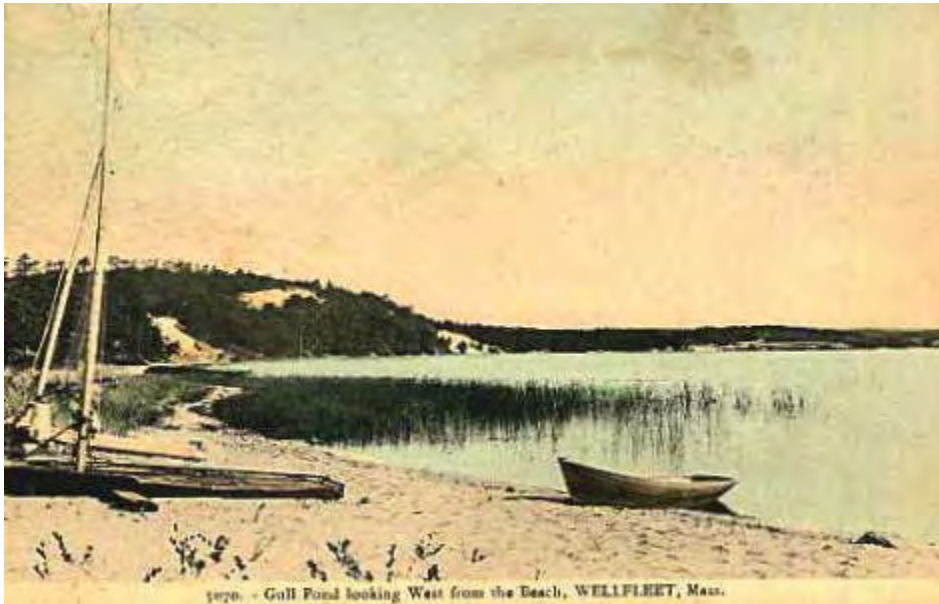
*Above: Postcard photo of the south/southwest shore of Gull Pond in early 1900s showing a stand of emergent macrophytes in the littoral zone that extends a considerable distance down the shoreline.*
